Manhole Inspection Summary

Manhole # S27M__005MH

Insp Date: **5/7/08 9:13 AM**

Location Address: **1021 Dexter st**

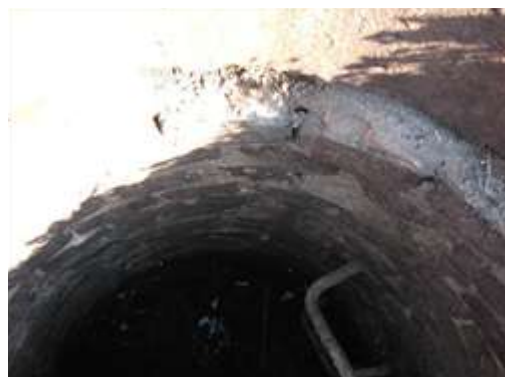
Defect 4

Offset: **1.5** (in.)

Condition: ☐ Sound ☐ Cracked ☒ **Leaks**

1.5 inch Offset

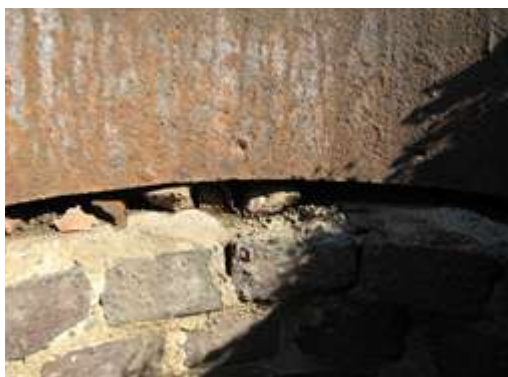
Defect 3

Condition: ☐ Sound ☐ Cracked ☐ Root Intrusion ☒ **Loose Brick** ☒ **Deteriorated**

chimney condition mortar, chimney cond
deteriorated

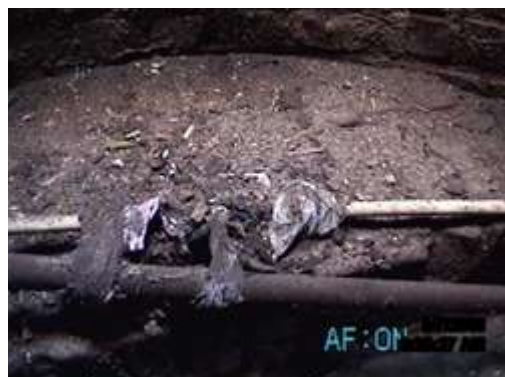
Defect 2

Condition: ☐ Sound ☐ Cracked ☐ Root Intrusion ☐ Deteriorated ☐ Leaks ☒ **Debris**

bench cond debris

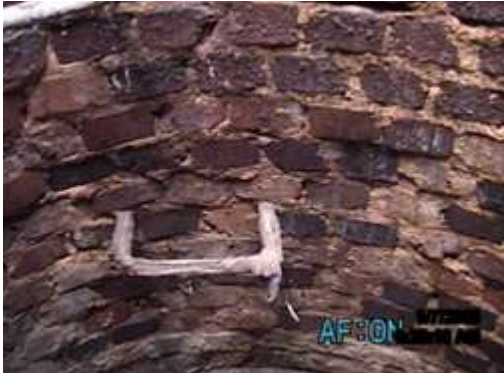
Defect 1

Count: **5** Missing: **0** ☒ **Corroded**

☒ **Evidence Of Surcharge** Depth: **1** (ft.) ☐ Active Surcharge Present

corroded steps, evidence of surcharge

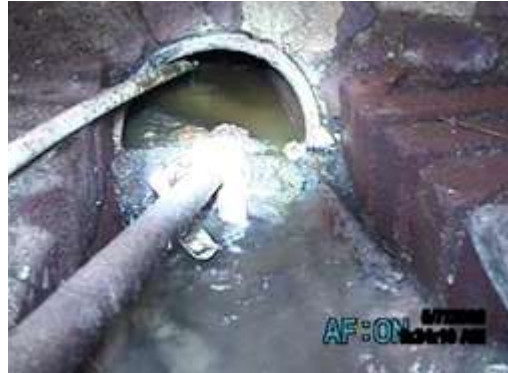
Defect 5

Condition: ☐ Sound ☐ Cracked ☐ Root Intrusion ☐ Deteriorated ☐ Leaks ☒ **Debris**

Debris in channel at 9oclock

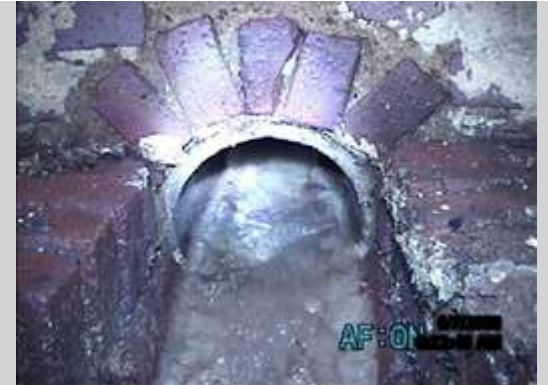
12 O'Clock Outflow

Pipe Height: **8.4** (in.) Rod and Bar (Angled)
Pipe Material: **Clay** ☐ Pipe Lined
Invert Depth: **9.08** (ft.) Flow Characteristics: **Fast**
Deposits: ☐ None ☐ Mud ☒ Sludge ☒ Debris ☐ Grease
Silt Depth: **2** (in.) Deposits Extent: **Medium**
Infiltration: **None** Pipe Seal Cond: **Sound**

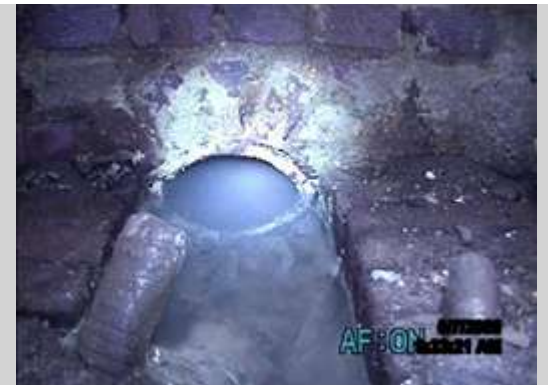
3 O'Clock Inflow

Pipe Height: **8.4** (in.) Rod and Bar (Angled)
Pipe Material: **Clay** ☐ Pipe Lined
Invert Depth: **8.83** (ft.) Flow Characteristics: **Slow**
Deposits: ☐ None ☐ Mud ☒ Sludge ☒ Debris ☐ Grease
Silt Depth: **4** (in.) Deposits Extent: **Heavy**
Infiltration: **None** Pipe Seal Cond: **Sound**

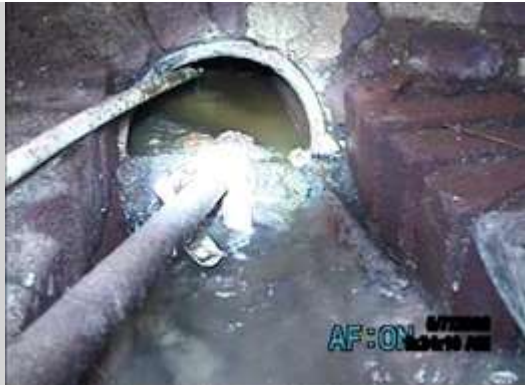
9 O'Clock Inflow

Deposits: ☐ None ☐ Mud ☐ Sludge ☒ **Debris** ☐ Grease

Silt Depth: **4** (in.) Deposits Extent: **Heavy**
